**CONDITION ASSESSMENT OF THE MECHANICAL,
ELECTRIC AND PLUMBING SYSTEMS
FOR**

**ST. MARK'S CAPITOL HILL
3RD AND A STREETS, SE
WASHINGTON, D.C.**

ECS Project No. 16216

Reference: Report of Mechanical, Electrical, and Plumbing Systems Condition Assessment
St. Mark's Capitol Hill
3rd and A Streets, SE
Washington, D.C.

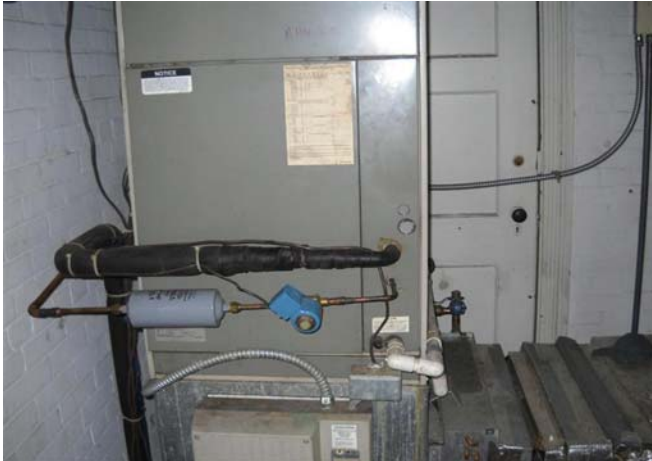
Photograph No. 1

Fan units are located in two mechanical rooms in the parish hall (Photograph No. 1), above the dance studio, mechanical rooms one through three in the undercroft (Photograph No. 2), and in closets F and G in the James R. Adams conference room (Photograph No. 3). The fan unit above the dance studio was not accessible; we were able to view the filters located in the changing room, and the filters were observed to be in good condition. Closet G was blocked and we were unable to access the fan unit inside. We were informed by Mr. Rupp that the fan unit in Closet G was manufactured by Bryant. We understand that the fan units were replaced during the remodel of the parish hall and undercroft in 1990. The expected useful life of a fan unit is approximately 20 to 25 years with proper maintenance. We recommend that an allowance be provided to replace the fan units.

Fan unit located in the mechanical room in the parish hall.

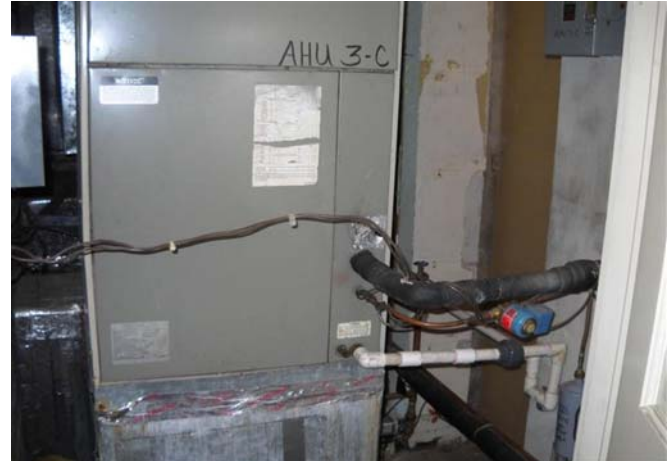
Photograph No. 2

Typical fan unit in the undercroft of the main church building.

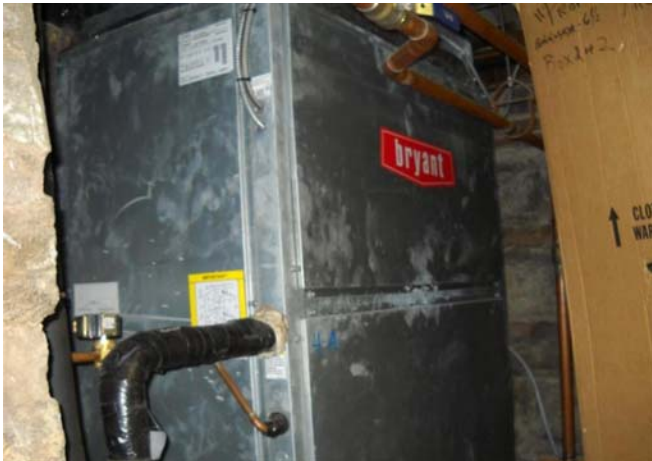
Photograph No. 3

Fan unit located in closet F in the undercroft of the main church building.

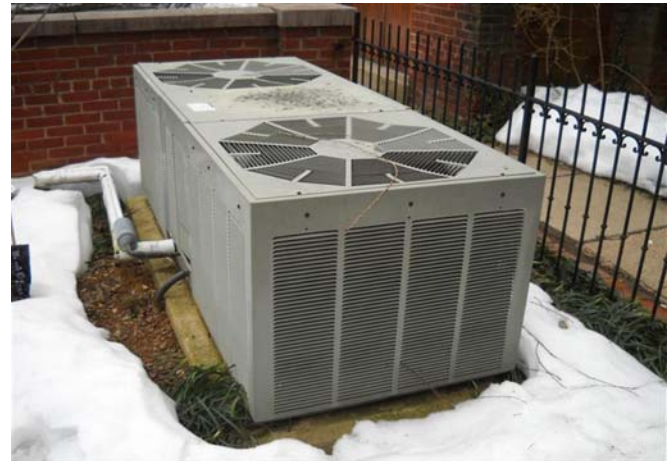
Photograph No. 4

The condenser units for the main church building are located on the south side of the building and behind the kitchen (Photograph Nos. 4 and 5). The fan units were observed to not be equipped with dryers of the refrigerant lines (Photograph No. 6 and 7). The condenser was observed to be in generally fair condition. The expected useful life of a condenser is approximately 20-25 years with proper maintenance. We recommend that an allowance be provided to replace the condensers.

Typical condenser unit for the main church building.

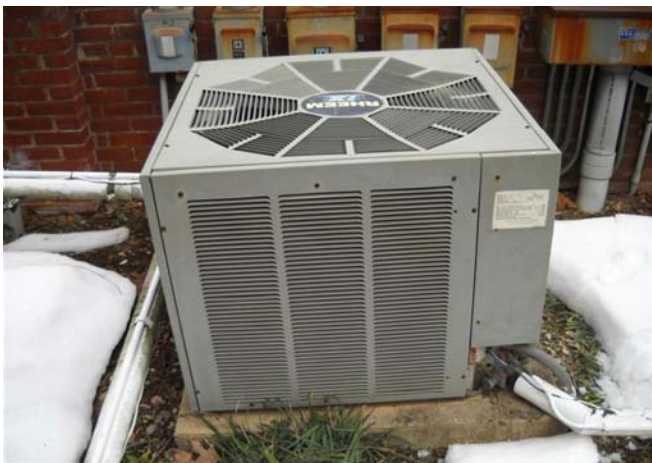
Photograph No. 5

Condenser unit located on the south side of the parish hall.

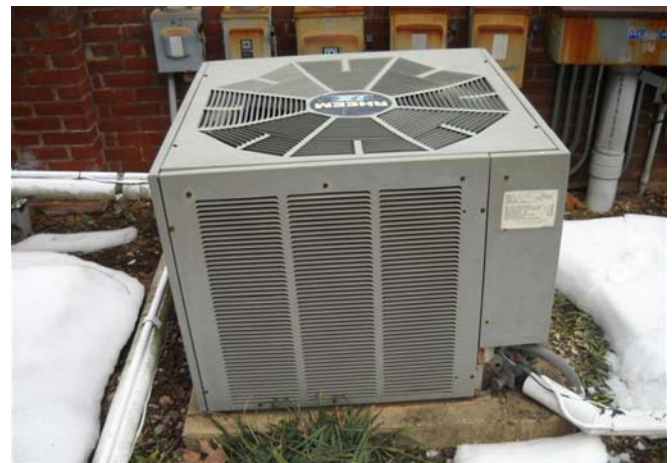
Photograph No. 6

Condenser unit located on the south side of the parish hall.

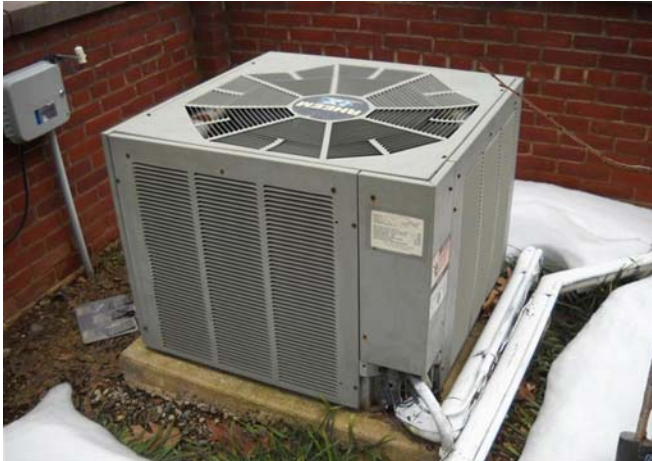
Photograph No. 7

Condenser unit located on the south side of the parish hall.

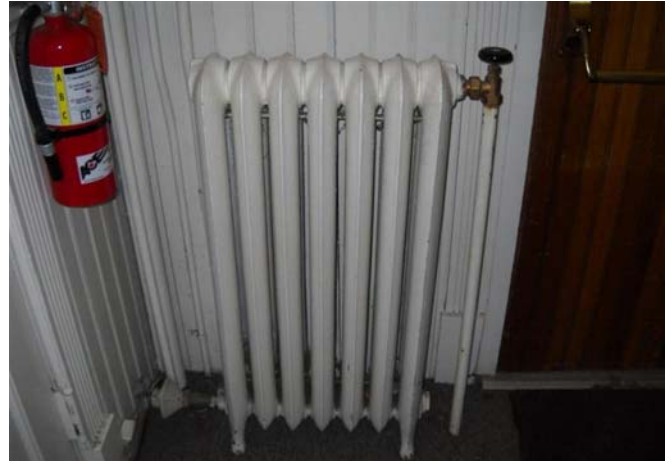
Photograph No. 8

Hot water radiator heaters are located throughout the church building (Photograph Nos. 8 through 10). The expected useful life of a radiator heater is approximately 35 years with proper maintenance. The radiator heaters were observed to be in generally fair condition.

Radiator unit located in the undercroft of the main church building.

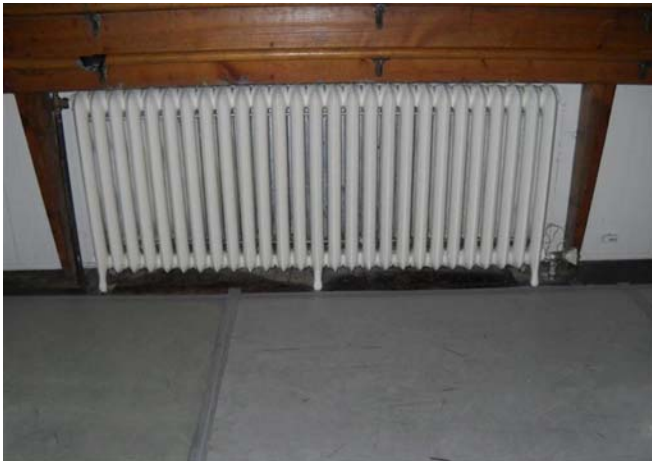
Photograph No. 9

Typical radiator located in the main church building.

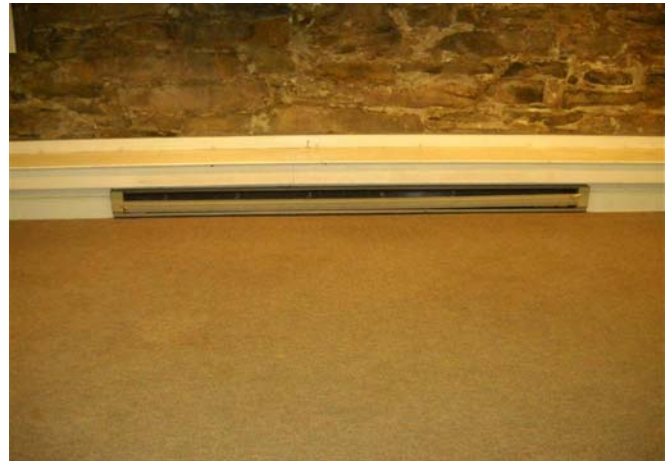
Photograph No. 10

Baseboard radiator located in the conference room in the undercroft of the main church building.

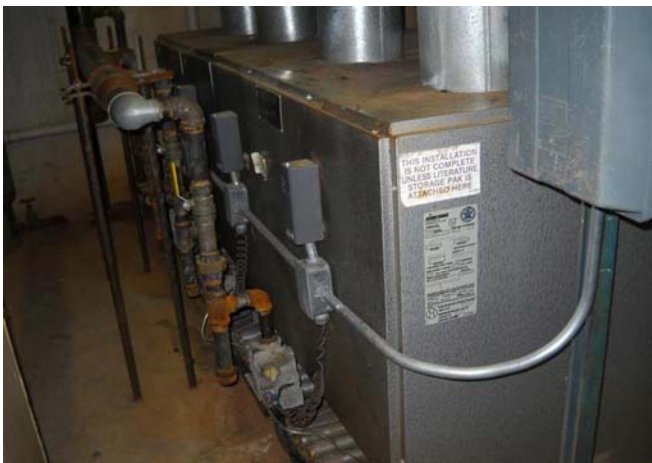
Photograph No. 11

The boilers are located in the undercroft of the church building (Photograph Nos. 11 and 12). The boilers are manufactured by HydroTherm, Model No. MR-1200B. The boilers were replaced in 1990 when the parish hall and undercroft were renovated. The expected useful life of a boiler is approximately 25 years with proper maintenance. The boilers were observed to be in generally fair condition. We recommend that an allowance be provided to replace the boilers.

Boilers located in the mechanical room for the main church building.

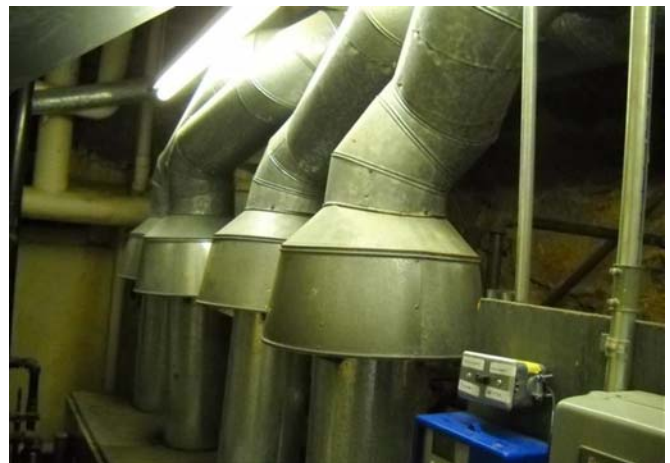
Photograph No. 12

Boiler exhaust piping in the mechanical room.

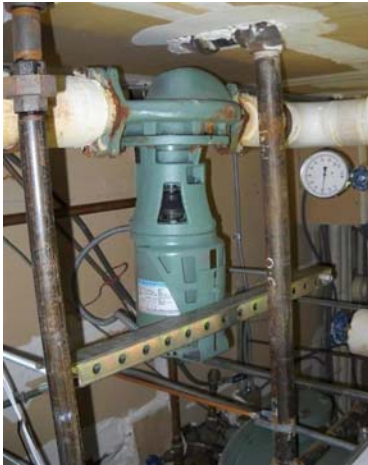
Photograph No. 13

A pump is located in the main mechanical room in the undercroft (Photograph No. 13). The pump motor was manufactured by Marathon, Model No. 7VL56T17D2100F, in October of 1990. The expected useful life of a pump is 15 years with proper maintenance. The pump was observed to be in generally fair condition. We recommend the pump be replaced.

Pump in the main mechanical room in the undercroft of the main church building.

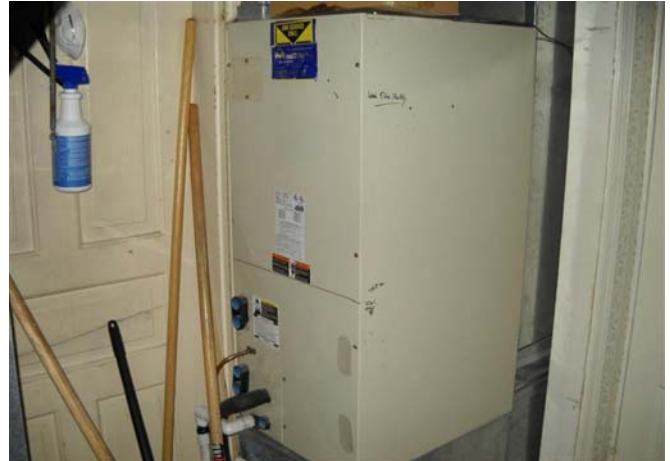
Photograph No. 14

Fan units are located in the bathroom on the first floor and in a mechanical closet in the third floor (Photograph Nos. 14 and 15). The fan units were manufactured by Bryant, Model Nos. FK4CNF002 and FK4CNF003. The fan units were observed to be in generally good condition. The expected useful life of a fan unit is approximately 20 to 25 years with proper maintenance. We recommend the fan units be replaced.

Fan unit located on the first floor of Baxter House.

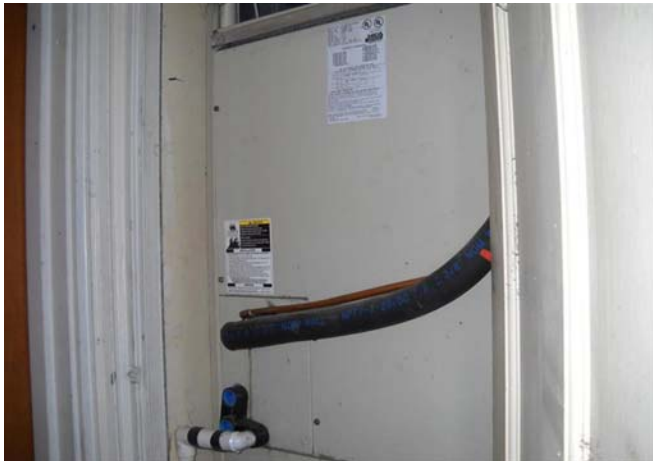
Photograph No. 15

Fan unit located on the third floor of Baxter House.

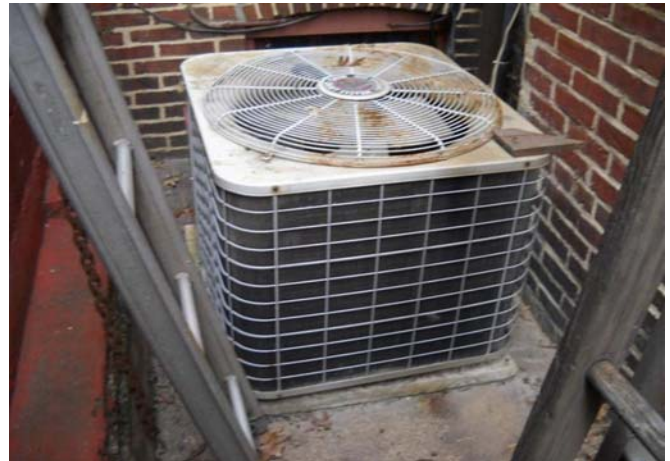
Photograph No. 16

The condenser unit for Baxter House is located on the south side of the building (Photograph No. 16). The condenser unit was manufactured by Bryant, Model No. 597CN024-B, in 2000. The condenser unit was not equipped with a dryer (Photograph No. 17). The condenser was observed to be in generally fair condition. The expected useful life of a condenser is approximately 20 to 25 years with proper maintenance. The condenser is connected to both fan units, thus the system throughout the building will be on or off. We recommend the condenser be replaced with two separate units, one for each fan unit.

Condenser unit located on the south side of Baxter House.

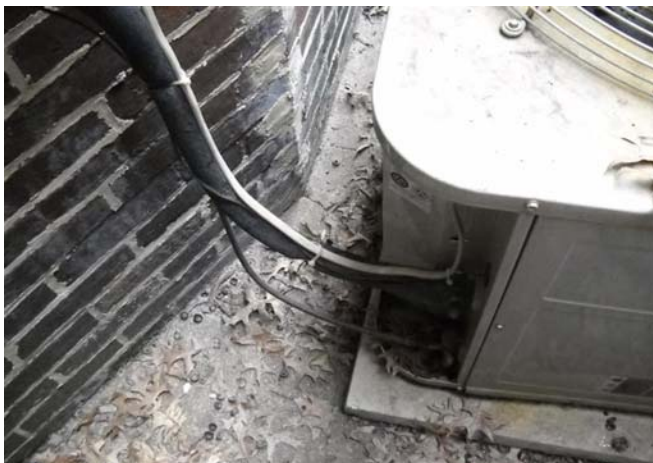
Photograph No. 17

Close-up of the condenser. Note that there is no dryer on the refrigerant line.

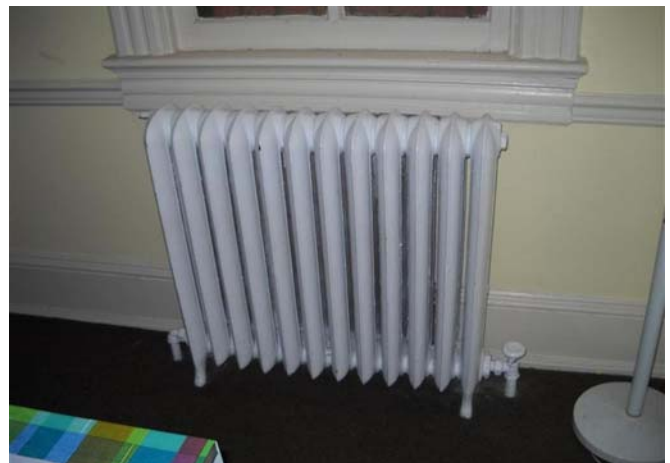
Photograph No. 18

Hot water radiator heaters are located throughout the building (Photograph Nos. 18 and 19). The expected useful life of a radiator heater is 35 years with proper maintenance. The radiator heaters were observed to be in generally fair condition.

Typical radiator located in Baxter House.

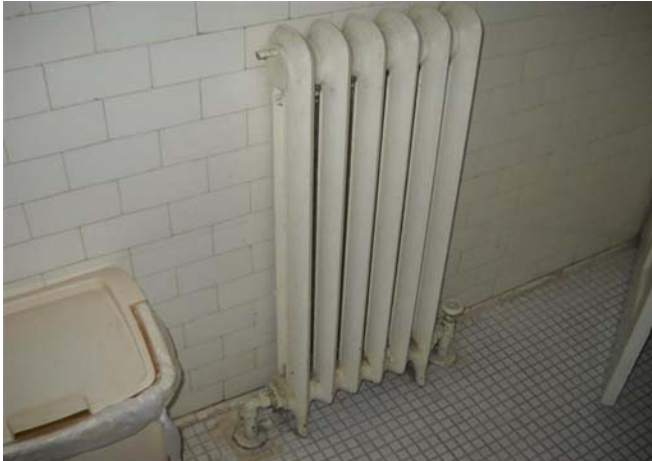
Photograph No. 19
Typical radiator located in Baxter House.

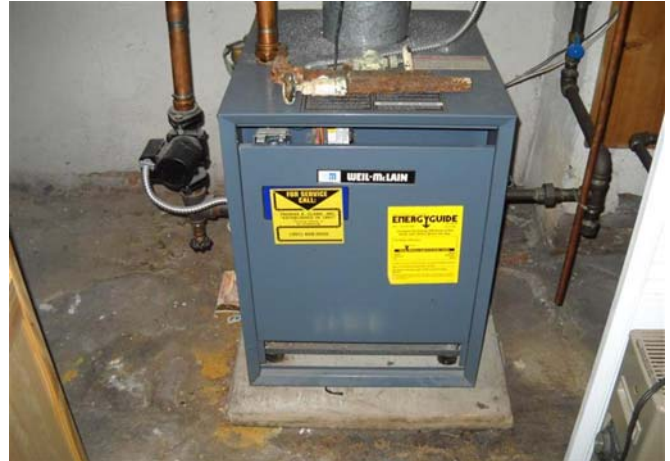
The boiler is located in the basement of the building (Photograph No. 20). The boiler is manufactured by Weil-McLain, Model No. CG-6-PIDN. The boiler was observed to be in generally fair condition. The expected useful life for a boiler is approximately 20 to 25 years. We recommend replacing the boiler.

Photograph No. 20
Boiler located in the basement of Baxter House.

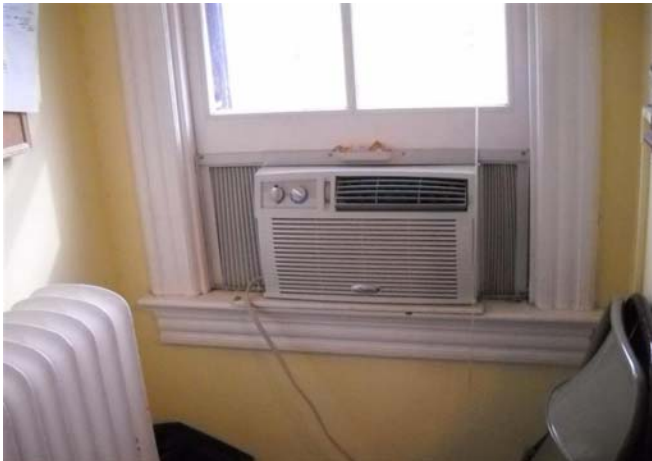
A through-the-wall air conditioning unit was observed in an office on the second floor (Photograph No. 21). The air-conditioner unit is utilized to supplement the main mechanical system. A portable heater is also located in the office with the air-conditioning unit. This is a symptom of the central heating and cooling system not operating properly in the building.

Photograph No. 21
Through-the-wall air-conditioning unit in a second floor office at Baxter House.

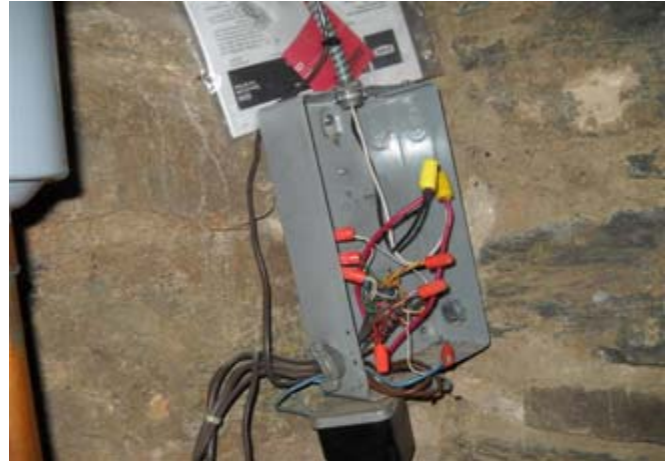
An open electrical box was observed in the mechanical room in the parish hall (Photograph No. 26). Open switches and damaged electrical outlets were observed throughout the building (Photograph Nos. 27 and 28). We recommend providing an allowance for electrical repairs.

Photograph No. 26
Open electrical box in the mechanical room in the parish hall.

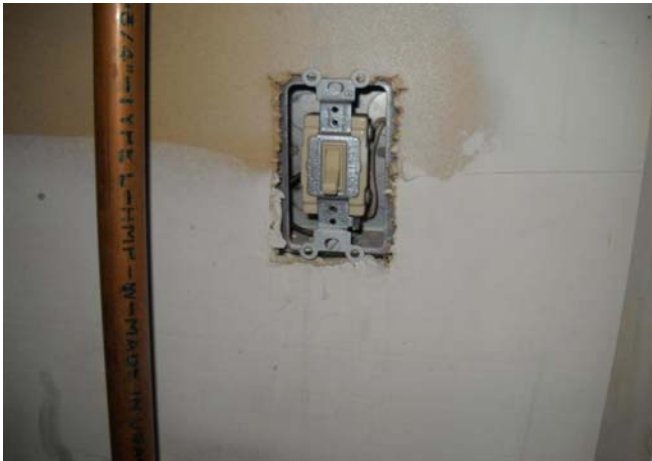
Photograph No. 27
Open electrical switch in the undercroft at the main church building.

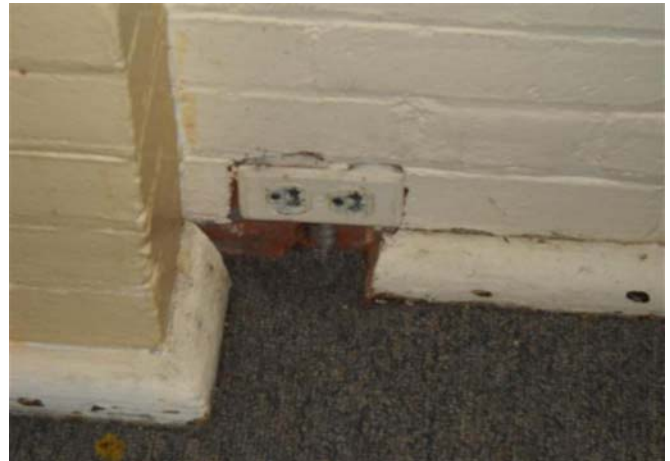
Photograph No. 28
Damaged electrical outlet in the conference room in the main church building.

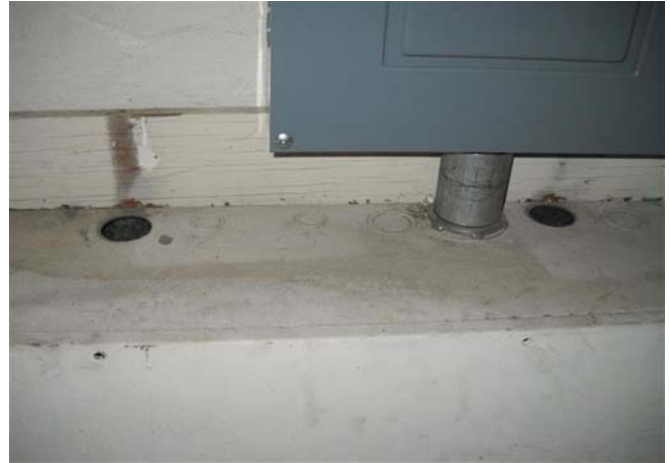
Photograph No. 32

Electricity is provided to Baxter House by PEPCO. The main electrical entrance for Baxter House is in the basement (Photograph No. 31). Holes here observed in the main electrical panel (Photograph No. 32). In the main electrical panel, both copper and aluminum wires were observed. Open wire was also observed in the panel (Photograph No. 33). The screws holding the door for the panel were missing.

Holes in the electrical entrance panel at Baxter House.

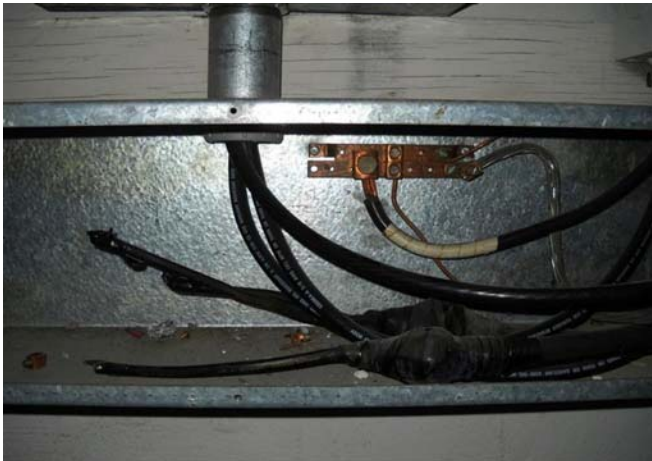
Photograph No. 33

Open electrical box and uncapped wires at the electrical entrance at Baxter House.

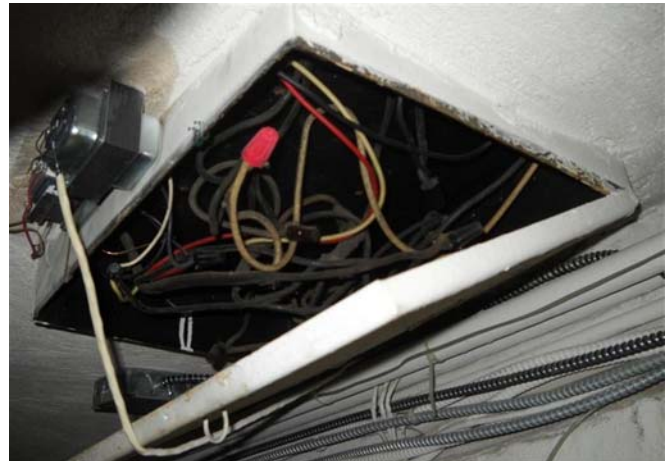
Photograph No. 34

An open electrical box was observed on the ceiling of the basement (Photograph No. 34). Open wires were observed in the box. Numerous wires were observed to have fabric casings that may contain hazardous materials.

Open electrical box in the ceiling of the basement at Baxter House.

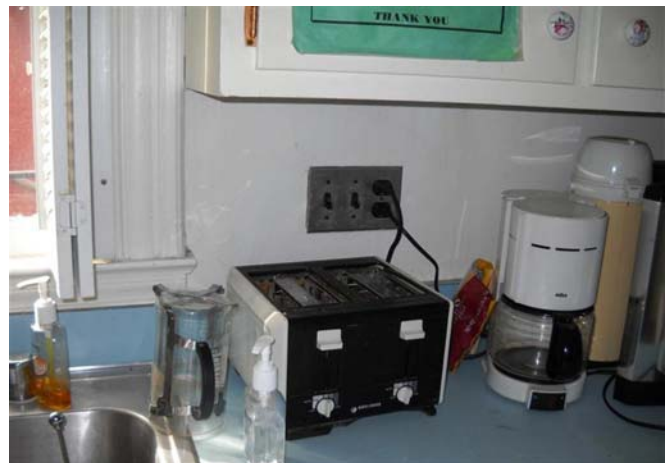
Photograph No. 36

The electrical lighting throughout Baxter House generally consists of incandescent fixtures (Photograph No. 35). The electrical outlets and switches were observed to be in generally fair condition (Photograph No. 36). The lighting was observed to be in good condition.

The outlet adjacent to the sink in Baxter House was not equipped with a ground fault circuit interrupter (GFCI) outlet. We recommend that a GFCI outlet be installed as a maintenance item.

Wall switch and outlets in the kitchen at Baxter House. Note the outlet is not a GFCI.

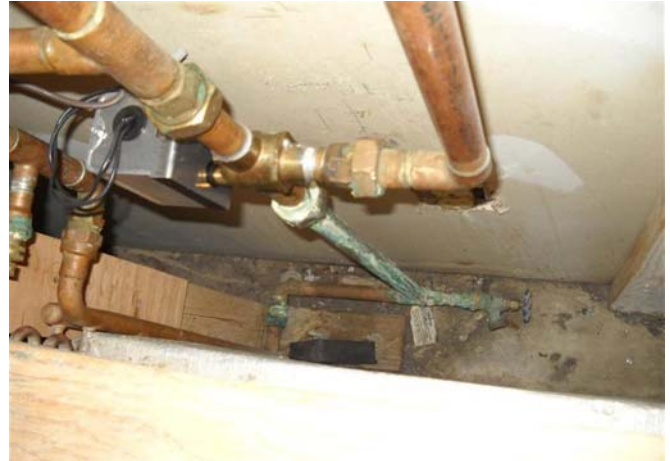
The plumbing system in the main church building includes copper water supply piping and cast iron and polyvinyl chloride (PVC) waste piping (Photograph No. 37). Leaks were observed in pipes in the undercroft (Photograph No. 38 and 39). The plumbing pipes were observed to be in generally fair to poor condition. We recommend that an allowance be provided to replace the deteriorated plumbing pipes.

Photograph No. 38
Leaking and damaged copper piping in the undercroft of the main church building.

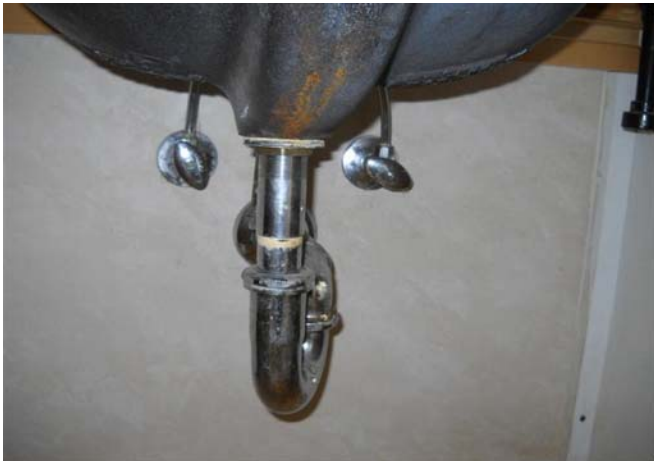
Photograph No. 39
Typical piping under sinks at the main church building.

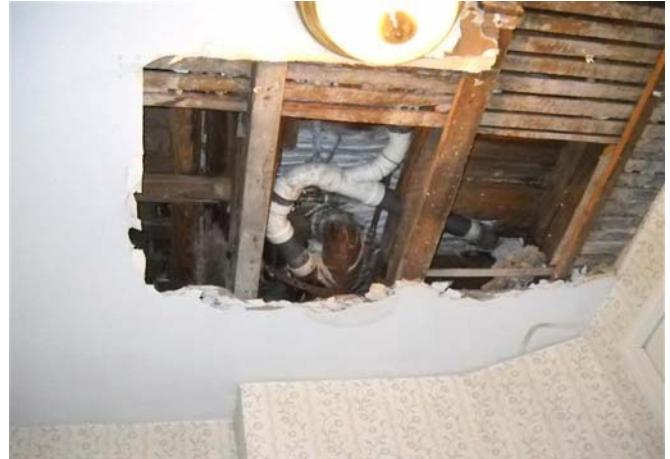
The plumbing system at Baxter House includes copper water supply piping and cast iron and PVC waste piping (Photograph Nos. 44 through 48). The plumbing pipes were observed to be in generally poor condition with previous leaks observed in the restrooms. A damaged drain was observed on the south side of the building (Photograph No. 49). We recommend that the area around the drain be repaired. We recommend that the plumbing pipes be replaced.

Photograph No. 46
Leaking waste piping exposed by a damaged ceiling on the first floor at Baxter House.

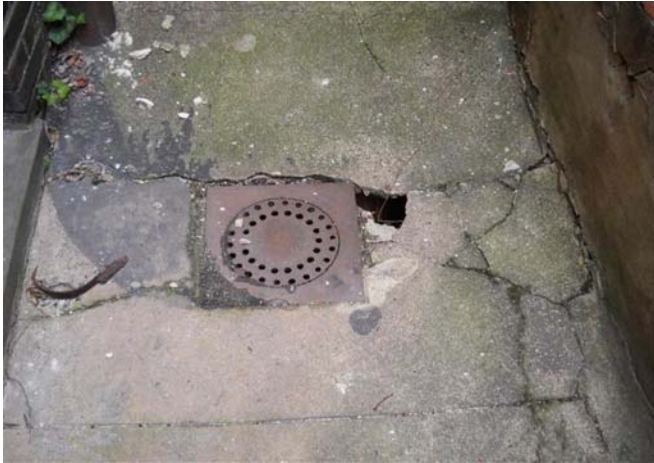
Photograph No. 49

Damaged concrete area around the drain on the south side of Baxter House.

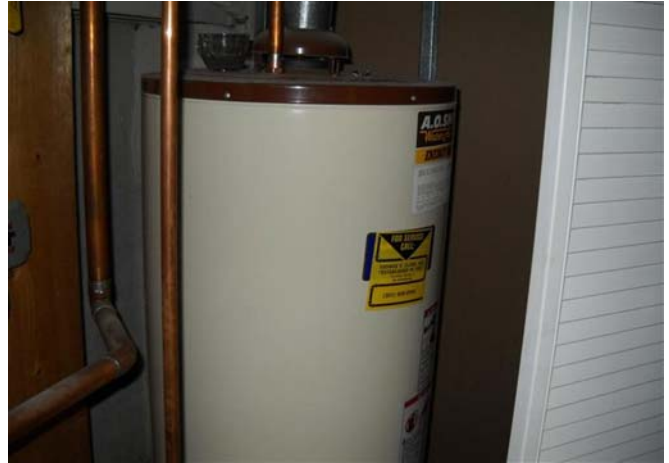
Photograph No. 50

Hot water for the building is provided by a water heater located in the basement (Photograph No. 50). The water heater was observed to be manufactured by A.O. Smith. The expected useful life of a water heater is 15 years with proper maintenance. The water heater was observed to be in generally fair condition. We recommend an allowance be provided to replace the water heater.

Water heater located in the basement at Baxter House.

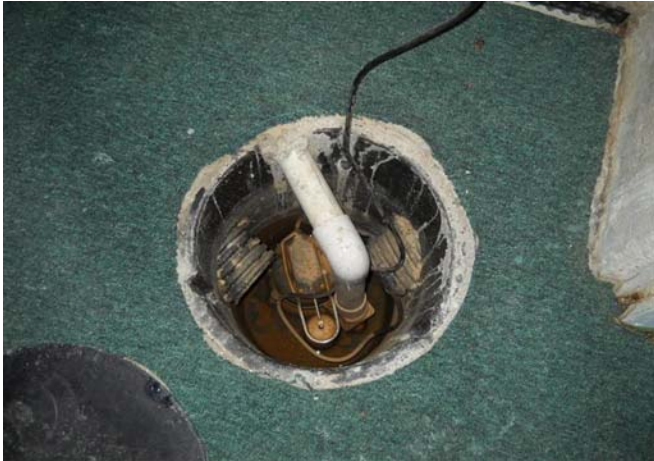
Photograph No. 51

A sump pump is located in the basement of the building (Photograph No. 51). The sump pump was observed to be in generally fair condition. We recommend an allowance be made to replace the sump pump.

Sump pump located in the basement at Baxter House.

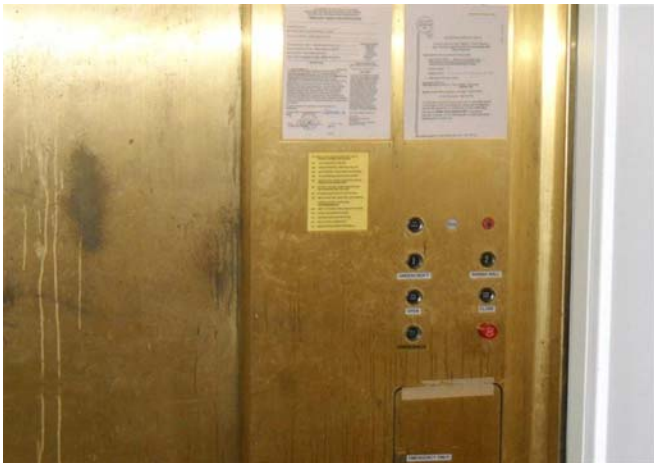
Photograph No. 53

The main church building is served by one hydraulic elevator manufactured and serviced by Otis Elevator Company. The elevator cab finishes included plastic laminated panel walls and tile floors. The plastic laminated walls were observed to be worn (Photograph No. 53). The elevator certificate was displayed in the elevator (Photograph No. 54). We recommend that the interior of the elevator cab be refurbished.

Elevator cab in the main church building.

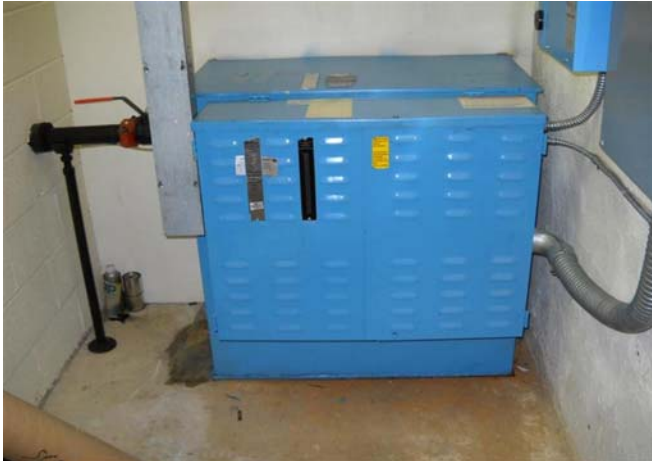
Photograph No. 55

The elevator equipment for the elevator is located in the undercroft (Photograph No. 55). The expected useful life of hydraulic elevator equipment is approximately 20 to 25 years with proper maintenance. We recommend that the elevator equipment be replaced.

The elevator equipment room in the undercroft of the main church building.
