**CONDITION ASSESSMENT OF THE MECHANICAL,
ELECTRIC AND PLUMBING SYSTEMS
FOR**

**ST. MARK'S CAPITOL HILL
3RD AND A STREETS, SE
WASHINGTON, D.C.**

ECS Project No. 16216

Reference: Report of Mechanical, Electrical, and Plumbing Systems Condition Assessment
St. Mark's Capitol Hill
3rd and A Streets, SE
Washington, D.C.

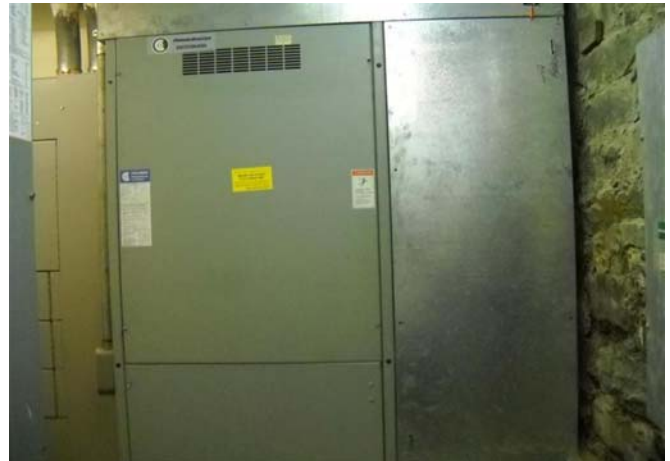
Electricity is provided to the church building by Potomac Electric Power Company (PEPCO). The main entrance and switchgear for the church is located in the undercroft (Photograph Nos. 22 and 23). The main switchgear provides 4,000 amps, 3-phase, 4-wire service. The electrical meters are located next to the switchgear in the electrical room. Power is distributed to circuit breaker panels located throughout the church (Photograph No. 24 and 25).

Photograph No. 22
Main electrical panel at the main church building.

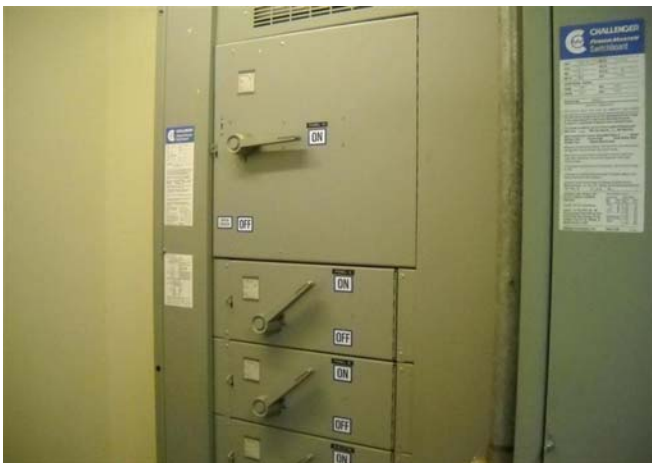
Photograph No. 23
Main electrical cut-off switches in the main church building.

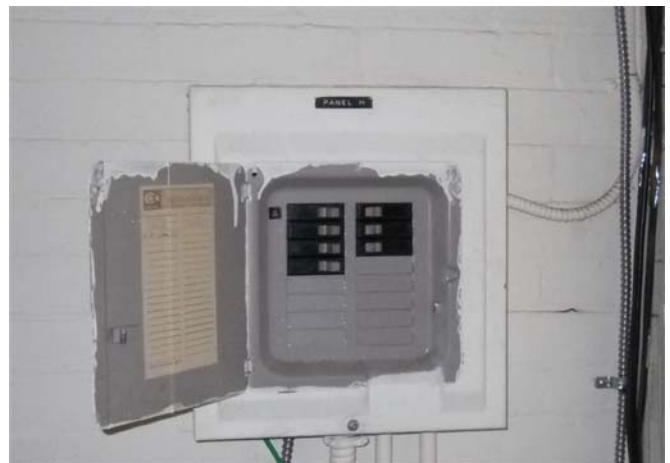
Photograph No. 24
Typical electrical panel located in the parish hall.

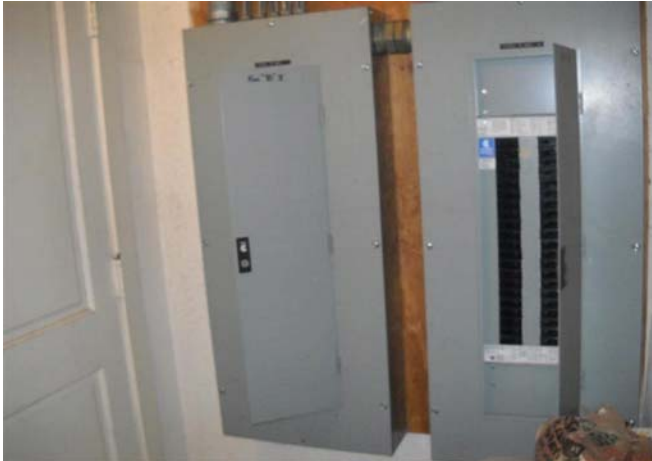
Photograph No. 25
Typical electrical panel located in the undercroft.

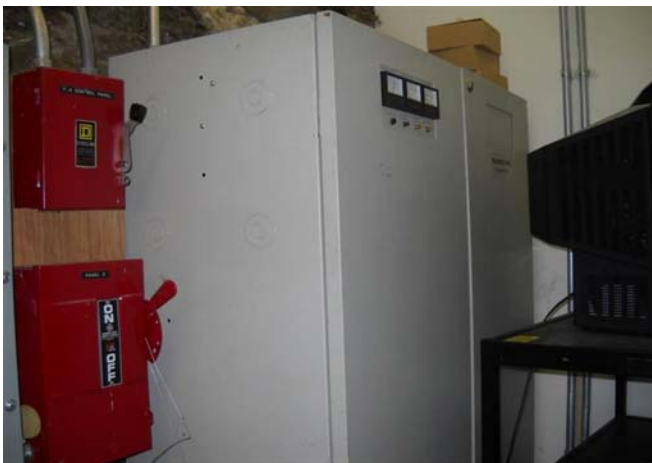
An emergency power panel is located in the electrical room in the undercroft (Photograph No. 29). The panel serves the fire alarm system and emergency lighting.

Photograph No. 29
Emergency power panel in the electrical room in the undercroft of the main church building.

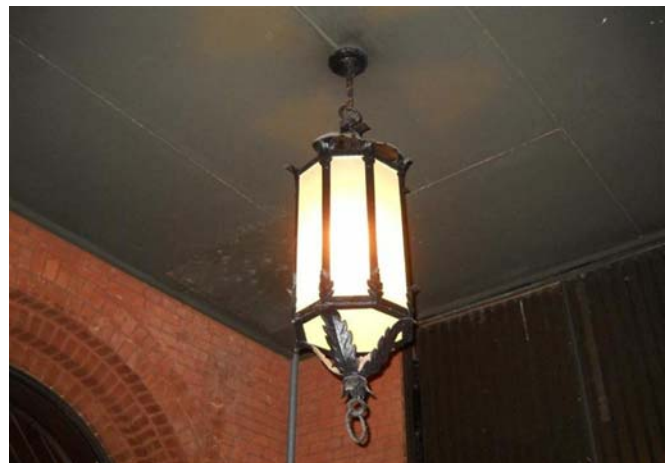
The electrical lighting throughout the main church building generally consists of incandescent and fluorescent fixtures (Photograph No. 30). The lighting was observed to be in generally good condition.

Photograph No. 30
Typical light fixture in the nave.

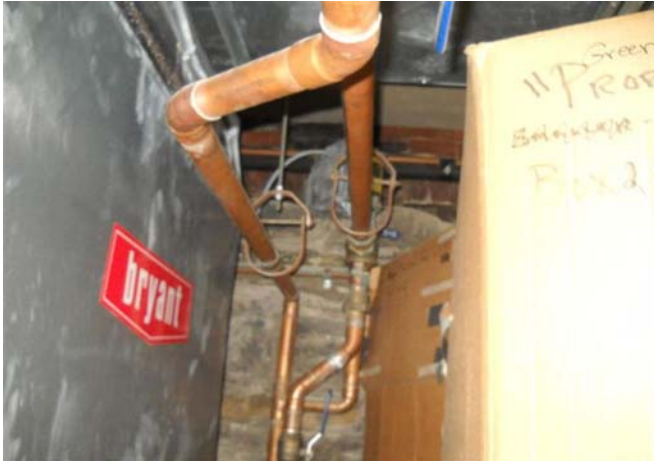
The plumbing system in the main church building includes copper water supply piping and cast iron and polyvinyl chloride (PVC) waste piping (Photograph No. 37). Leaks were observed in pipes in the undercroft (Photograph No. 38 and 39). The plumbing pipes were observed to be in generally fair to poor condition. We recommend that an allowance be provided to replace the deteriorated plumbing pipes.

Photograph No. 37
Typical copper piping at the main church building.

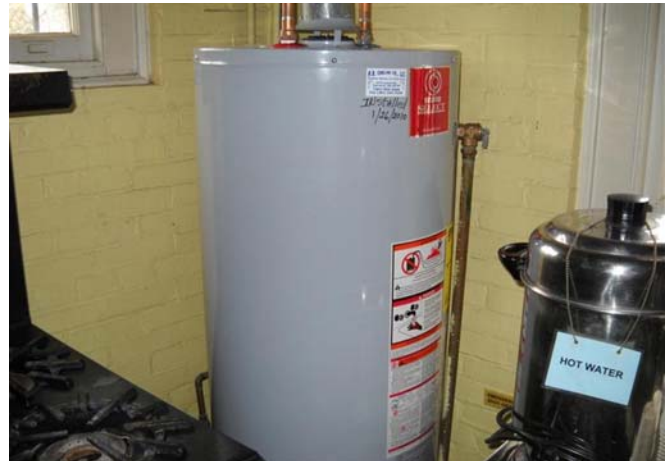
Hot water for the church is provided by two water heaters. The water heaters are located in the kitchen of the parish hall and main mechanical room in the undercroft (Photograph Nos. 40 and 41). The water heater in the kitchen was observed to be manufactured by State, Model No. G5650YBRT. The water heater in the undercroft was manufactured for Bradford-White, Model No. M-I-73775BN. A compression tank manufactured by PACO, Model No. CAX170 (Photograph No. 42) is located adjacent to the water heater in the undercroft. The water heater in the kitchen was manufactured in October of 2009 and was observed to be in good condition. The water heater in the undercroft was manufactured in September of 1990 and was observed to be in generally fair condition. The expected useful life of a water heater is approximately 15 years. We recommend the water heater in the undercroft be replaced.

Photograph No. 40
Water heater in the kitchen at the parish hall.

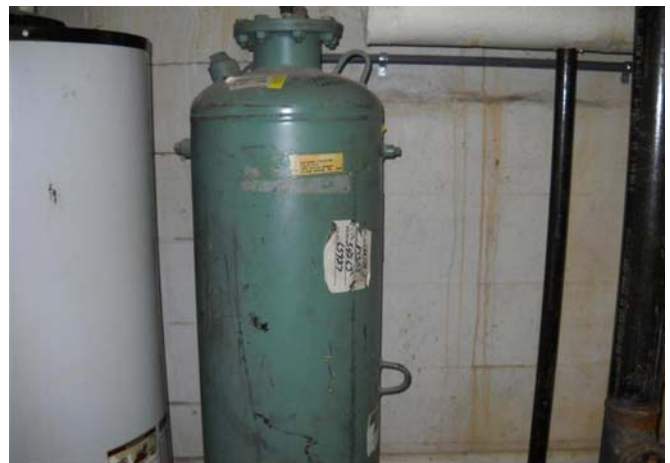
Photograph No. 42
Compression tank for the water heater in the main mechanical room.

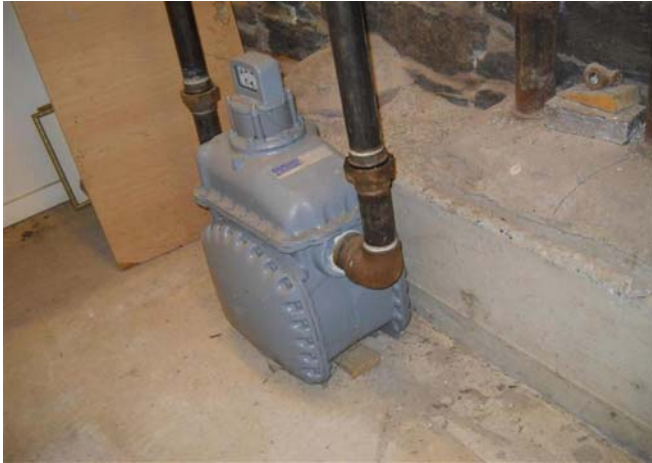
The natural gas entrance and meter are located in the undercroft of the building (Photograph No. 43). The natural gas is provided by Washington Gas. The meter was observed to be in generally fair condition.

Photograph No. 43
Main gas entrance and meter at the main church building.

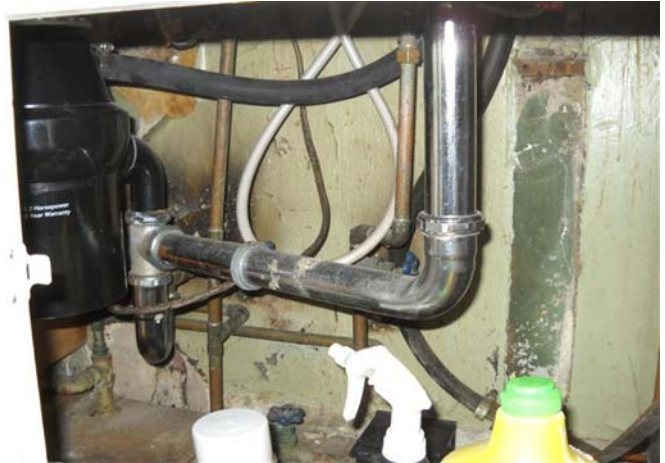
Photograph No. 44
Typical waste and supply piping at Baxter House.

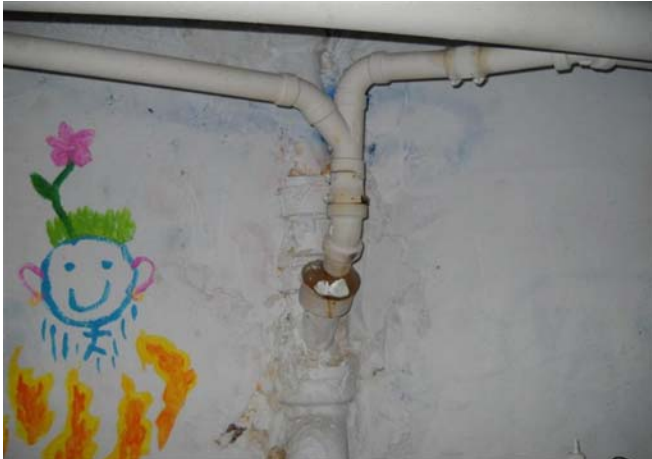
Photograph No. 45
Typical waste piping in the basement of Baxter House.

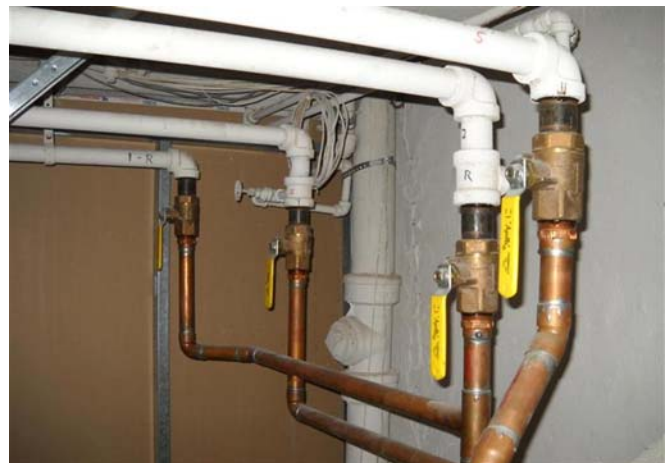
Photograph No. 48
Typical pipe work in the basement of Baxter House.
