**CONDITION ASSESSMENT OF THE MECHANICAL,
ELECTRIC AND PLUMBING SYSTEMS
FOR**

**ST. MARK'S CAPITOL HILL
3RD AND A STREETS, SE
WASHINGTON, D.C.**

ECS Project No. 16216

Reference: Report of Mechanical, Electrical, and Plumbing Systems Condition Assessment
St. Mark's Capitol Hill
3rd and A Streets, SE
Washington, D.C.

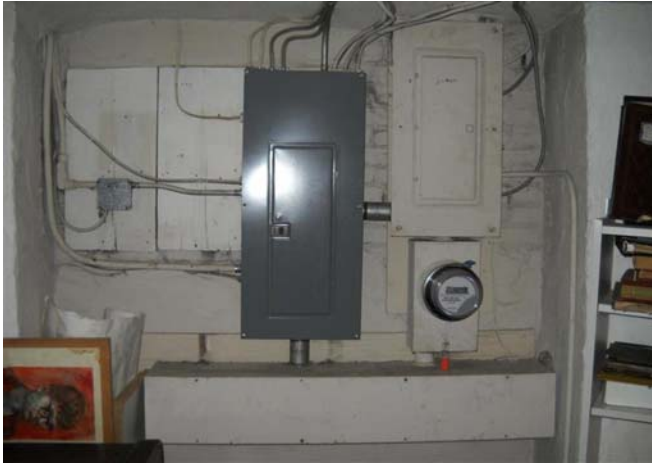
Photograph No. 31

Electricity is provided to Baxter House by PEPCO. The main electrical entrance for Baxter House is in the basement (Photograph No. 31). Holes here observed in the main electrical panel (Photograph No. 32). In the main electrical panel, both copper and aluminum wires were observed. Open wire was also observed in the panel (Photograph No. 33). The screws holding the door for the panel were missing.

Main electrical entrance and panel in the basement at Baxter House.

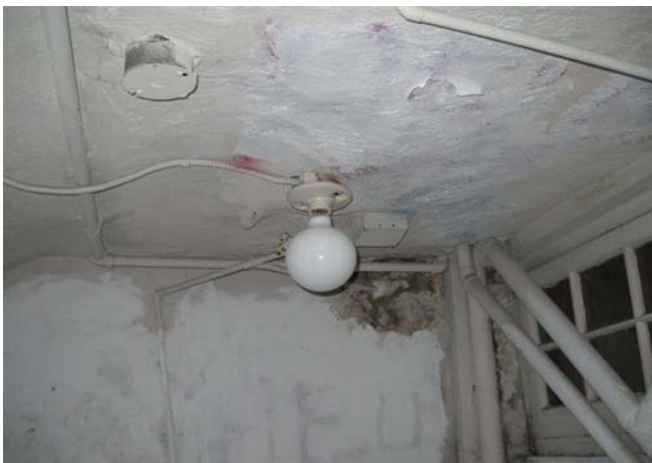
Photograph No. 35

The electrical lighting throughout Baxter House generally consists of incandescent fixtures (Photograph No. 35). The electrical outlets and switches were observed to be in generally fair condition (Photograph No. 36). The lighting was observed to be in good condition.

Typical light fixture in the basement at Baxter House.

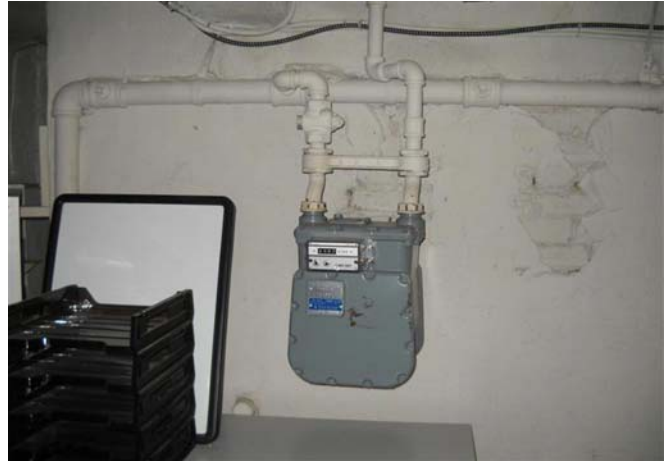
Photograph No. 52

The natural gas entrance and meter are located in the basement of the building (Photograph No. 52). The natural gas is provided by Washington Gas. The meter was observed to be in generally fair condition.

Main gas entrance and meter in the basement at Baxter House.

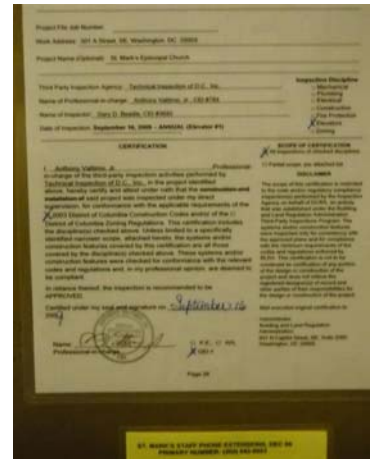
Photograph No. 54

The main church building is served by one hydraulic elevator manufactured and serviced by Otis Elevator Company. The elevator cab finishes included plastic laminated panel walls and tile floors. The plastic laminated walls were observed to be worn (Photograph No. 53). The elevator certificate was displayed in the elevator (Photograph No. 54). We recommend that the interior of the elevator cab be refurbished.

Elevator inspection certificate for the main church building.

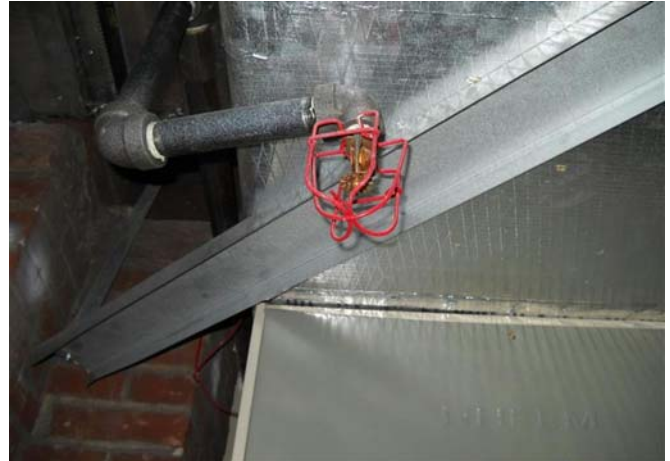
Photograph No. 56

Sprinkler head in the undercroft of the main church building.

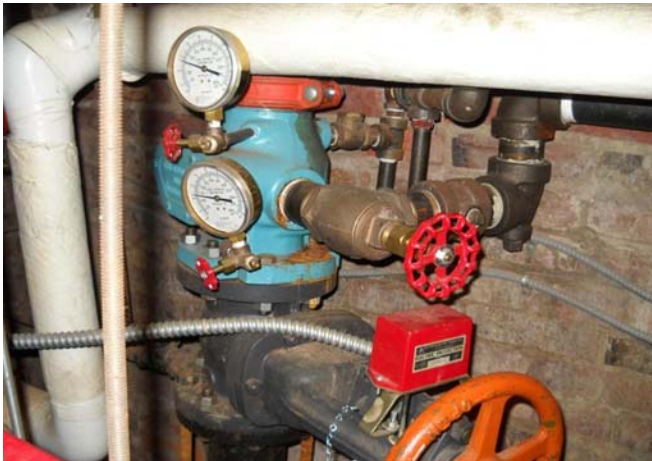
Photograph No. 57

Sprinkler valve in the undercroft of the main church building.

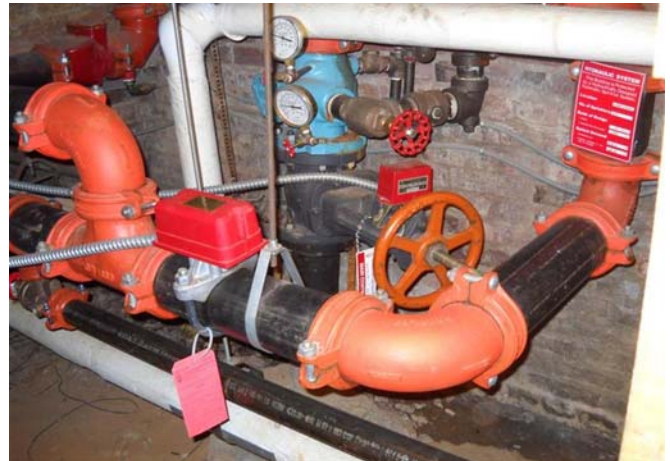
Photograph No. 58

Sprinkler piping in the undercroft of the main church building.

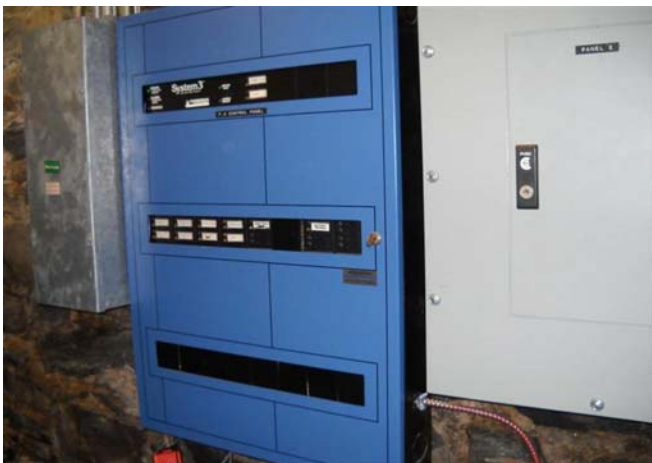
Photograph No. 59

A fire alarm control panel for the main church building is located in the electrical room in the undercroft of the building (Photograph No. 59). An annunciator panel is located in the foyer of the church (Photograph No. 60).

Fire alarm control panel in the electrical room of the main church building.

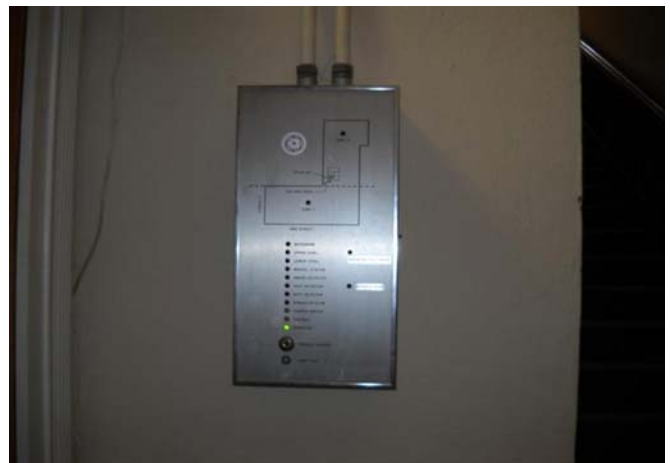
Photograph No. 60

Fire annunciator panel located in the foyer of the main church building.

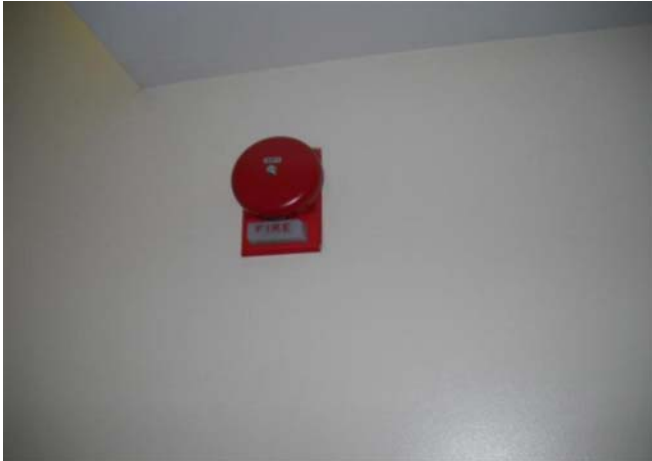
Photograph No. 61

Typical fire alarm bell and strobe in the main church building.

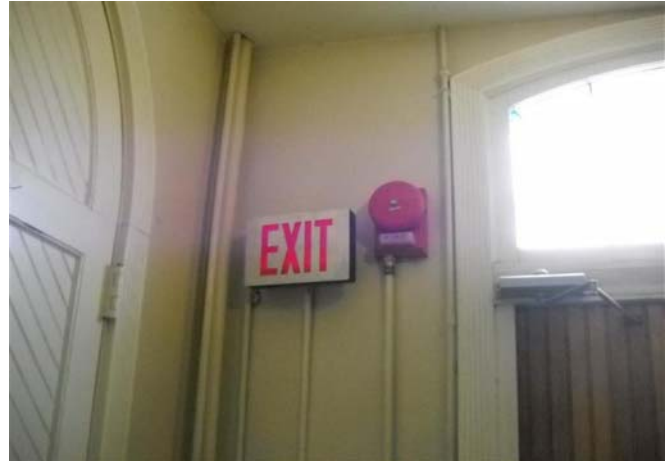
Photograph No. 62

Typical exit sign, strobe, and bell for the main church building.

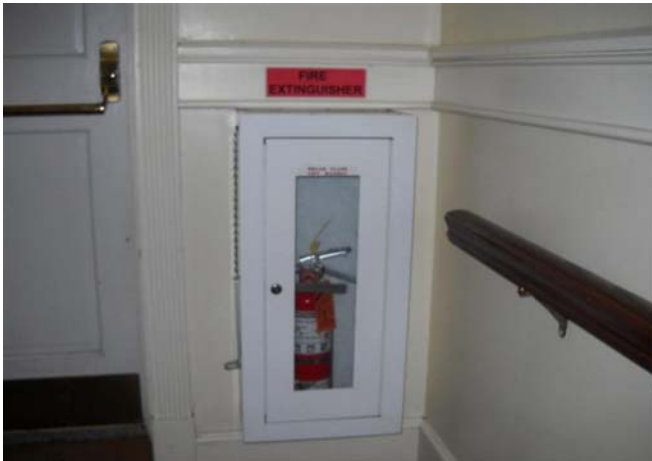
Photograph No. 63

Typical fire extinguisher in the main church building.

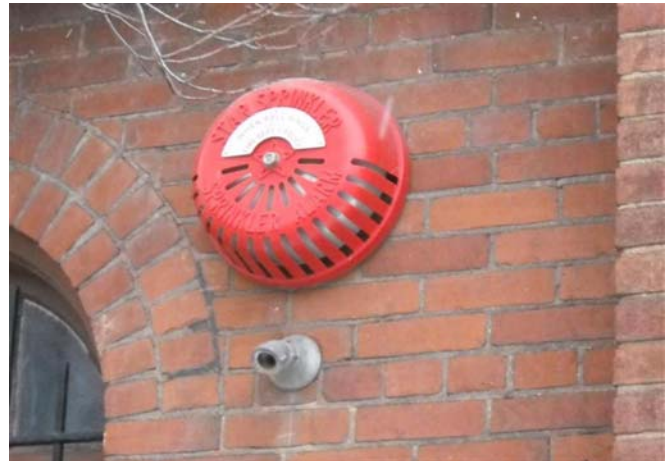
Photograph No. 64

Fire alarm bell on the exterior of the main church building.

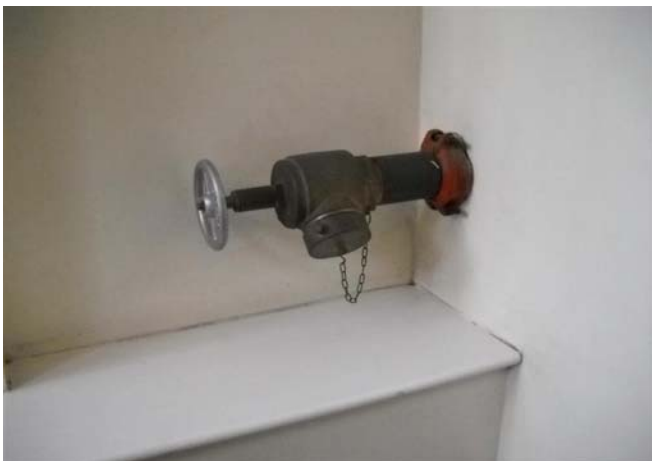
Photograph No. 65

Fire hose connector located in the stairwell to the undercroft in the main church building.

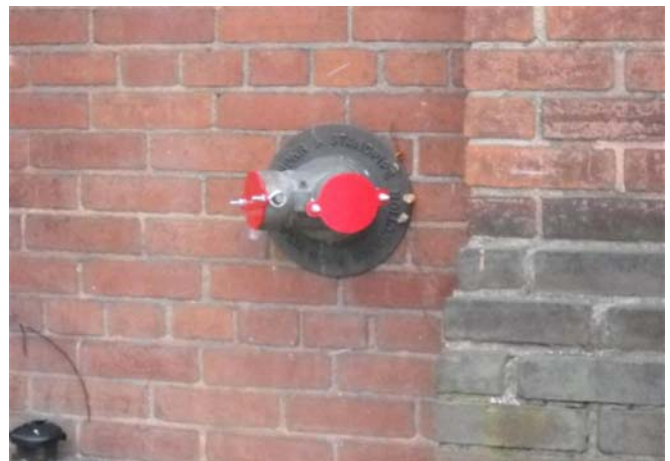
Photograph No. 66

Fire hose connector on the exterior of the parish hall.

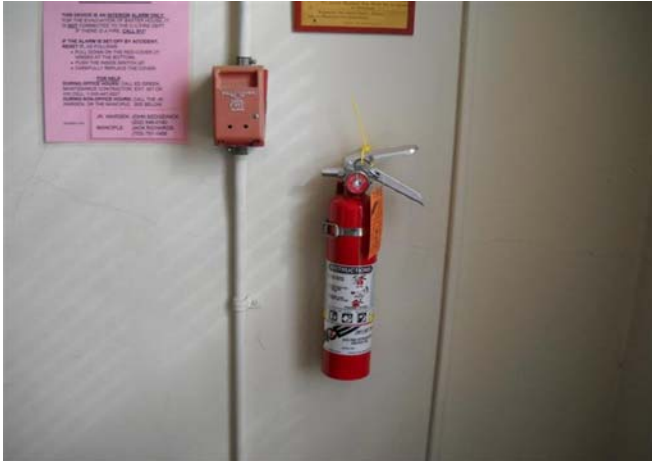
Photograph No. 67

Typical pull station and fire extinguisher in Baxter House.

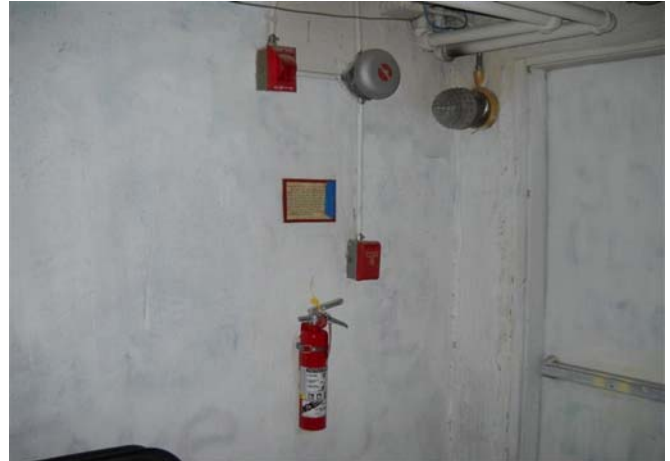
Photograph No. 68

Alarm bell, pull station, and strobe in Baxter House.

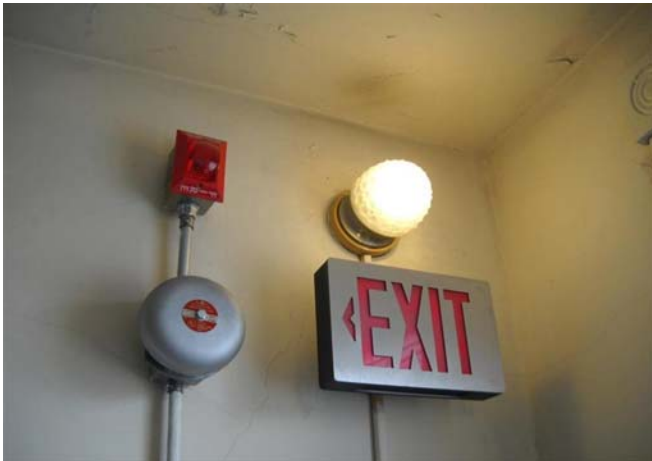
Photograph No. 69

Typical exit sign, alarm bell, and strobe in Baxter House.

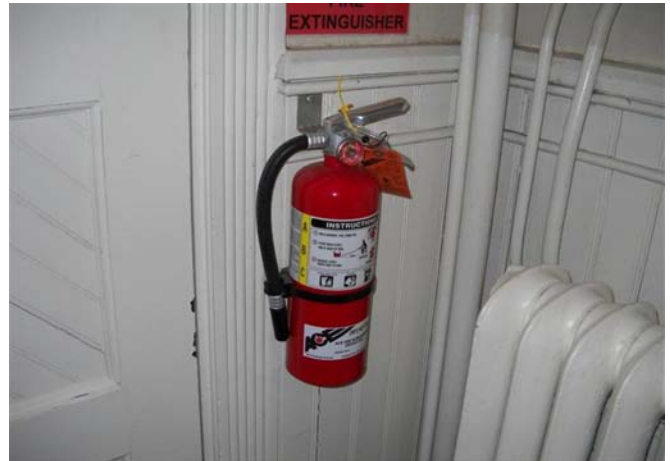
Photograph No. 70

Typical fire extinguisher in Baxter house.
